**Subject: Harris-Thomas Industries Site Assessment Report**  
**Dayton, Montgomery County, Ohio**  
**Technical Direction Document No.: S05-0001-1202-004**  
**WESTON START Contract No.: EP-S5-06-04**  
**Document Control No.: 1736-2A-AVHO**

**SITE ASSESSMENT REPORT  
FOR THE  
HARRIS-THOMAS INDUSTRIES SITE  
DAYTON, MONTGOMERY COUNTY, OHIO  
SITE ID NO. C5D3**

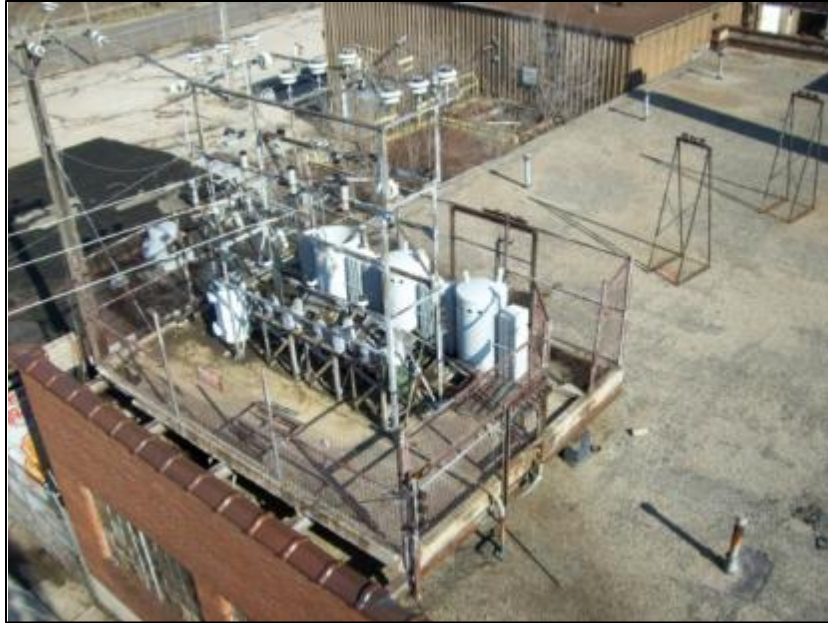
**Photograph No.:** 1

**Subject:** Transformers on roof of Area G building

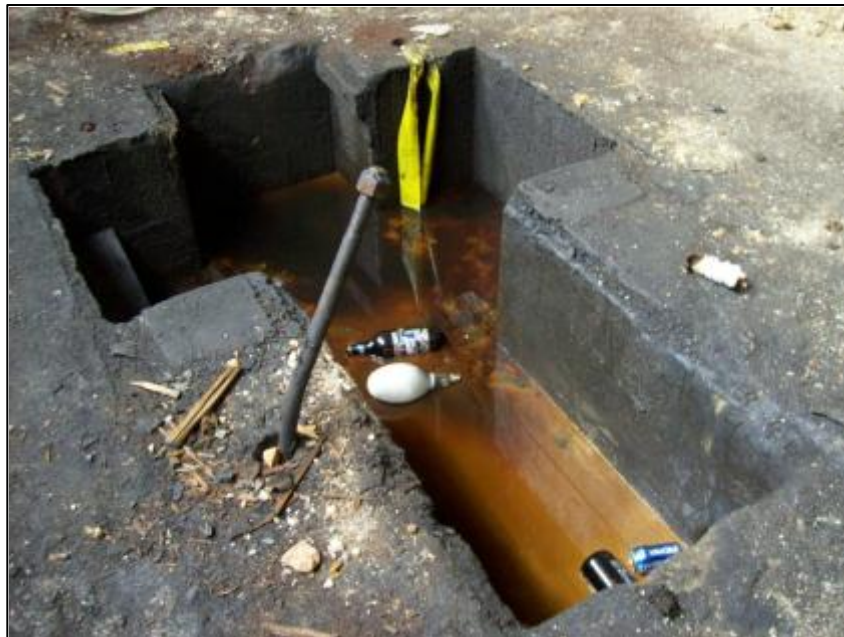
**Photograph No.:** 2

In Area A, WESTON START observed six small pits containing unknown liquid and debris. The liquid appeared similar to hydraulic oil. The area also contained four 55-gallon drums.

**Subject:** One of six small pits containing unknown liquids in Area A

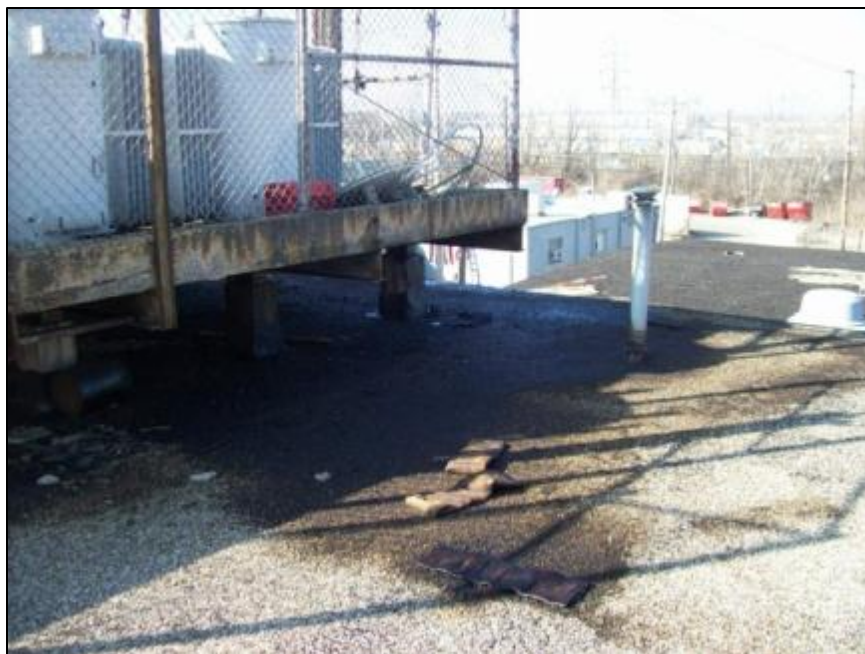
**Photograph No.:** 6

**Subject:** Transformer oil staining on roof of the Area G building

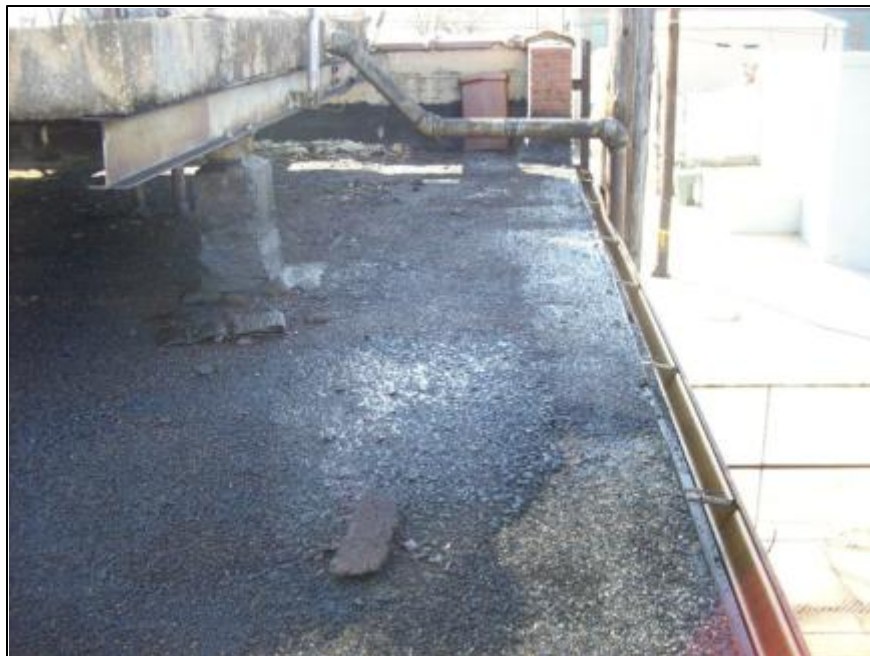
**Photograph No.:** 7

**Subject:** Transformer oil staining on roof and standing oil in roof gutters of Area G building

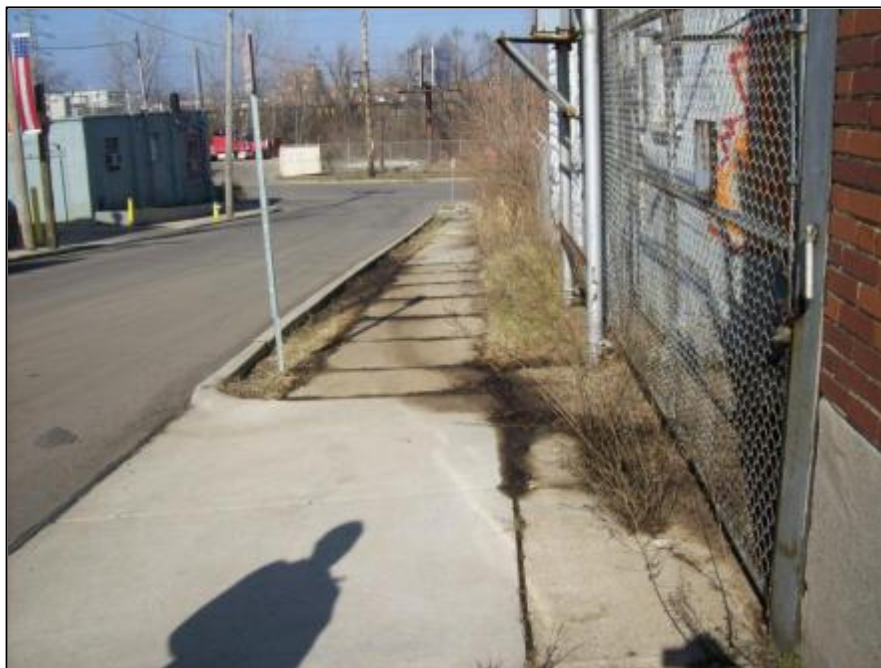
**Photograph No.:** 8

On February 2, 2012, the Dayton Fire Department (DFD) and the Ohio Environmental Protection Agency (Ohio EPA) investigated a report of oil leaking from a Site building onto a City of Dayton right-of-way sidewalk along Harshman Street. Site trespassing and vandalism (from metal scrappers) resulted in the release of transformer oil potentially containing polychlorinated biphenyls (PCB) to the Area G building (see **Figure 2-2**), its roof, and the adjacent sidewalk. The DFD and Ohio EPA inspected the building and observed not only the oil released from transformers on the roof but also numerous abandoned 55-gallon drums, containers, and pits of unknown liquids. The Ohio EPA requested emergency stabilization assistance from the U.S. EPA.

**Subject:** Transformer oil staining on City of Dayton right-of-way sidewalk

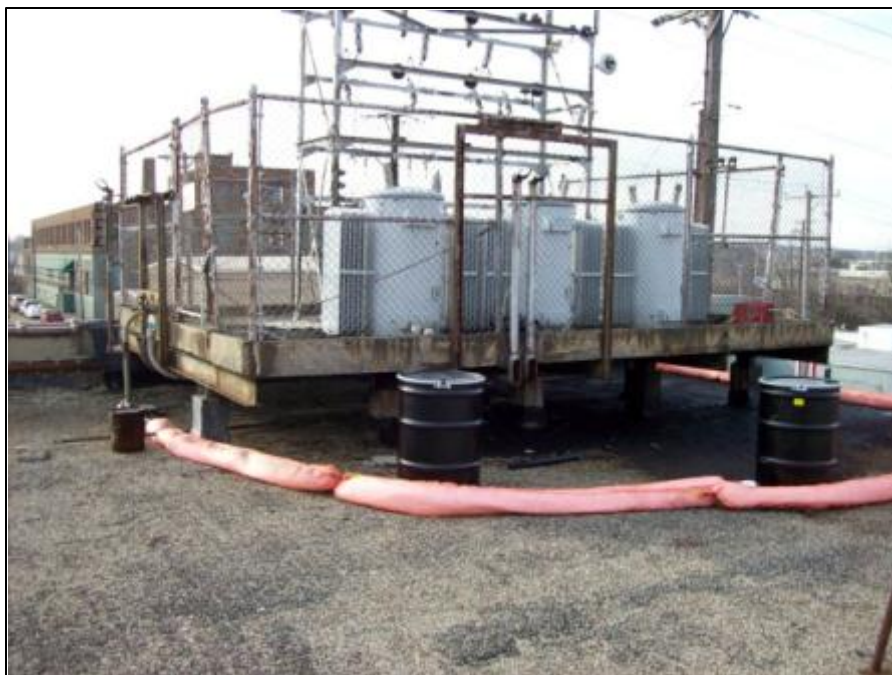
**Photograph No.:** 9

**Subject:** Transformer cage secured and absorbent boom deployed during ERRS stabilization activities

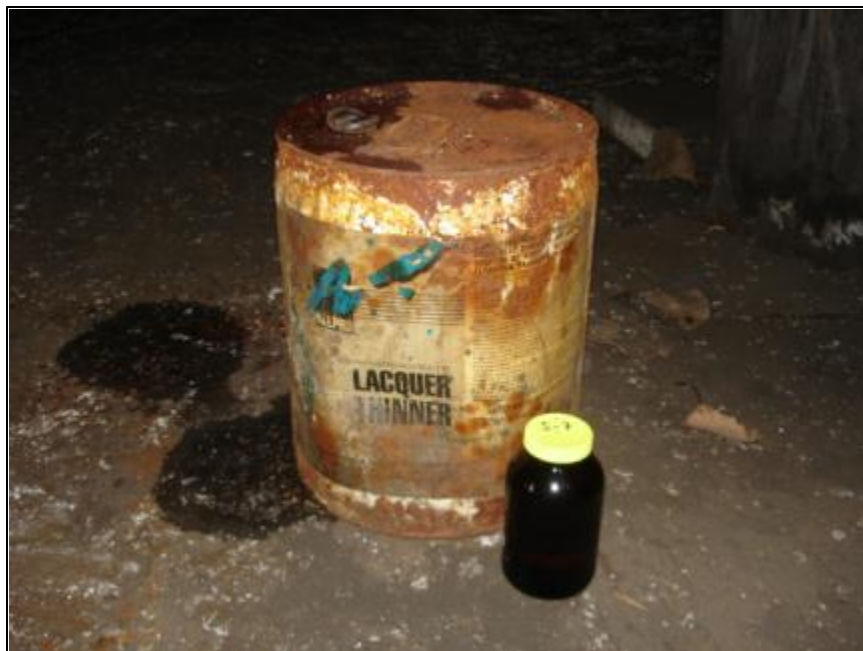
**Photograph No.:** 10

- **Toxicity - TCLP VOCs:** Liquid waste sample S-7 contained a TCLP methyl ethyl ketone (MEK) concentration of 170,000 milligrams per liter (mg/L). This result exceeds the TCLP MEK regulatory limit of 200.0 mg/L. Therefore, according to 40 CFR 261.24, liquid waste sample S-7 represents a material that meets the definition of a hazardous waste by virtue of the characteristic of toxicity.

**Subject:** Container from which investigative waste liquid sample S-7 was collected; sample had flashpoint less than 58 °F and TCLP MEK concentration of 170,000 mg/L

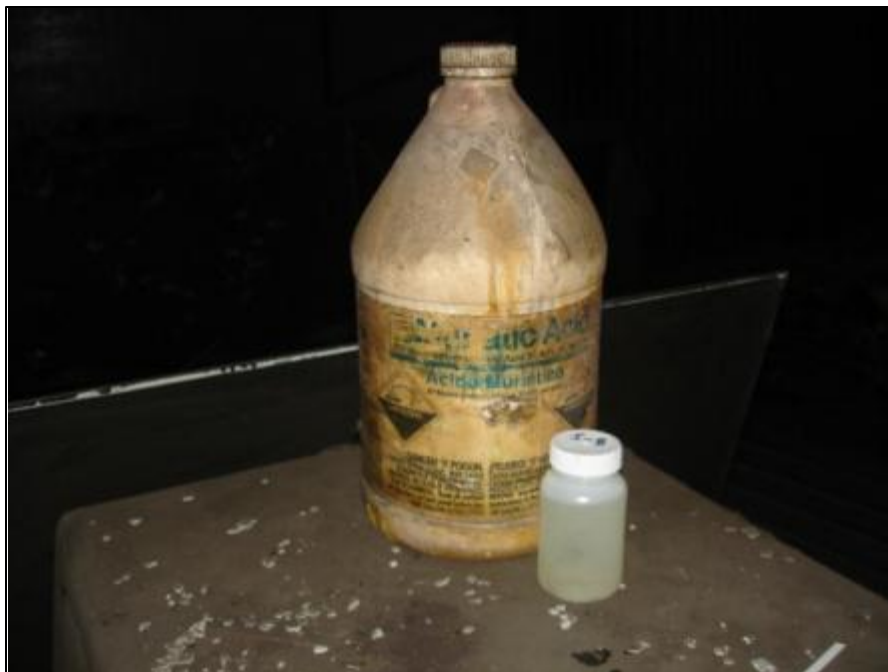
**Photograph No.:** 11

- **Corrosivity - pH:** The pH result for liquid waste sample S-8 was less than 2 SUs. Therefore, according to 40 CFR 261.22, the waste sample represents a material that meets the definition of a hazardous waste by virtue of the characteristic of corrosivity.

**Subject:** Container from which investigative waste liquid sample S-8 was collected; sample had a pH of 1.0 SU

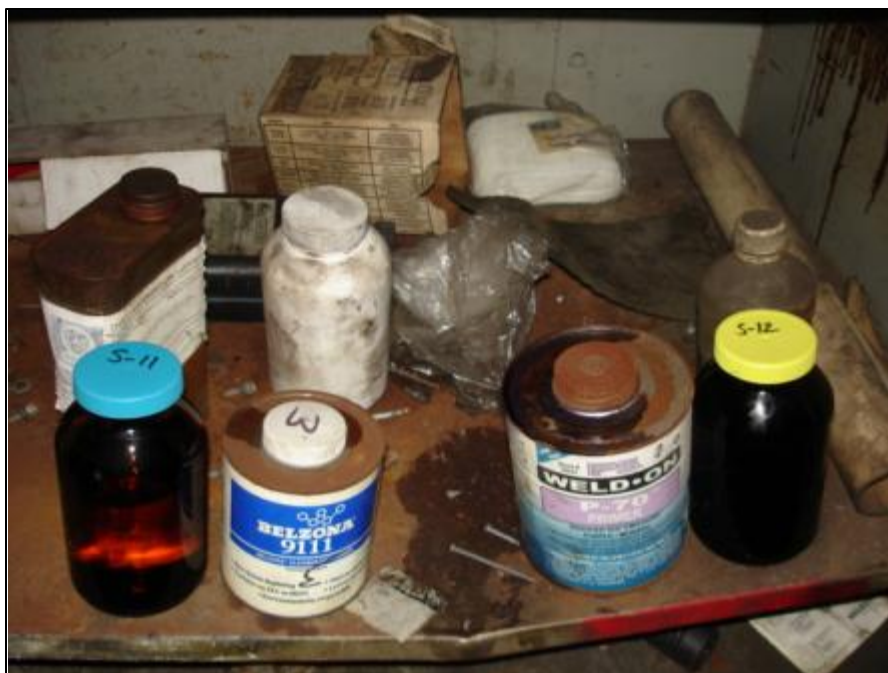
**Photograph No.:** 12

- **Ignitability – Flashpoint:** All flashpoint results for liquid waste samples S-7, S-11, and S-12 were less than 140 degrees Fahrenheit (°F), with a low flashpoint of less than 58 °F. Therefore, according to 40 CFR 261.21, these liquid waste samples represent materials that meet the definition of a hazardous waste by virtue of the characteristic of ignitability.

**Subject:** Containers from which investigative liquid waste samples S-11 and S-12 were collected, which had flashpoints of 120 °F and less than 58 °F, respectively

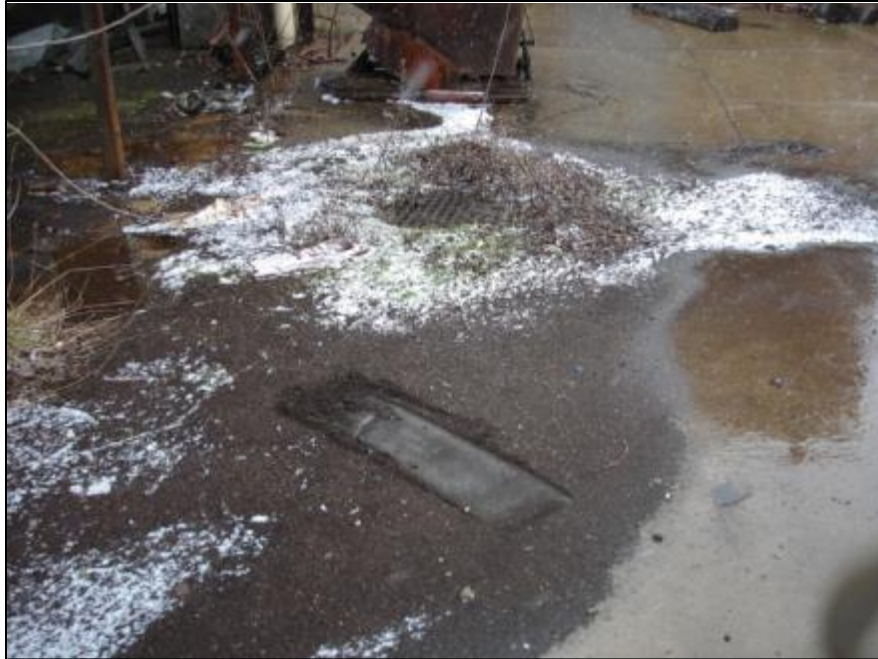
**Photograph No.:** 13

Site assessment XRF readings for total chromium were as high as 7,085 ppm and for total lead were as high as 1,035 ppm in waste piles within 5 feet of a stormwater drain. Rainwater entering the buildings could cause the migration of floor sweepings, waste piles, and wall solids containing chromium into the environment.

**Subject:** Lead-contaminated solid waste within 5 feet of stormwater drain

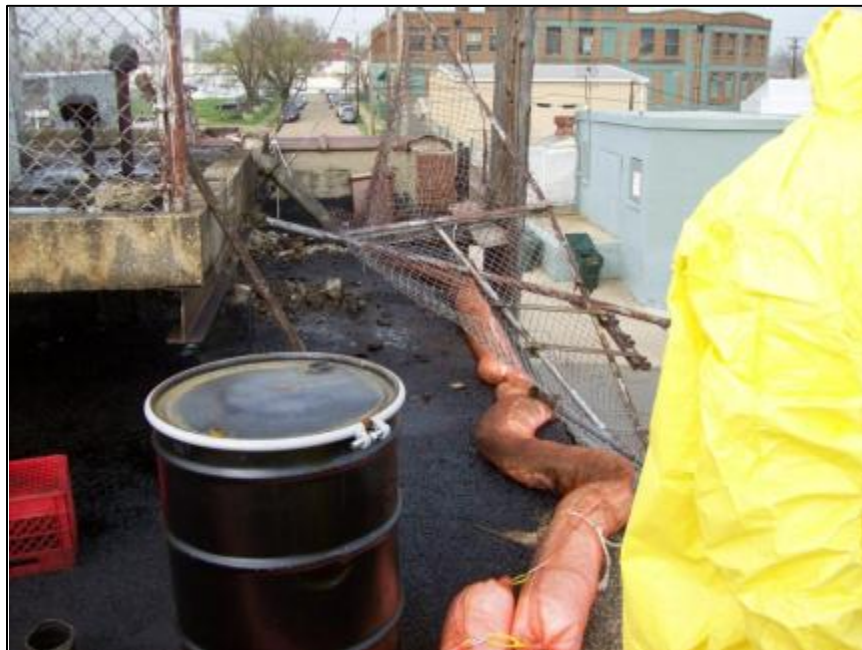
**Photograph No.:** 14

On March 20, 2012, WESTON START and the ERRS contractor remobilized to the Site and observed that the fencing around the transformers had been breached, one of the transformers had been stolen, and oil in the transformer had been released (see **Appendix A**). The ERRS contractor applied absorbent floor-dry material to areas of pooled oil and stained areas on the roof, ground, and sidewalk along Harshman Street. The ERRS contractor also replaced absorbent boom impacted by the previous release and added additional layers of absorbent boom to the point where the release exited the Site.

**Subject:** Vandalized transformer cage; transformer oil released onto roof
